Report No. CG-D-05-94

AIRCRAFT CORROSION STUDY

J.T. Stropki
and
R.D. Smith

FINAL REPORT
December 1993

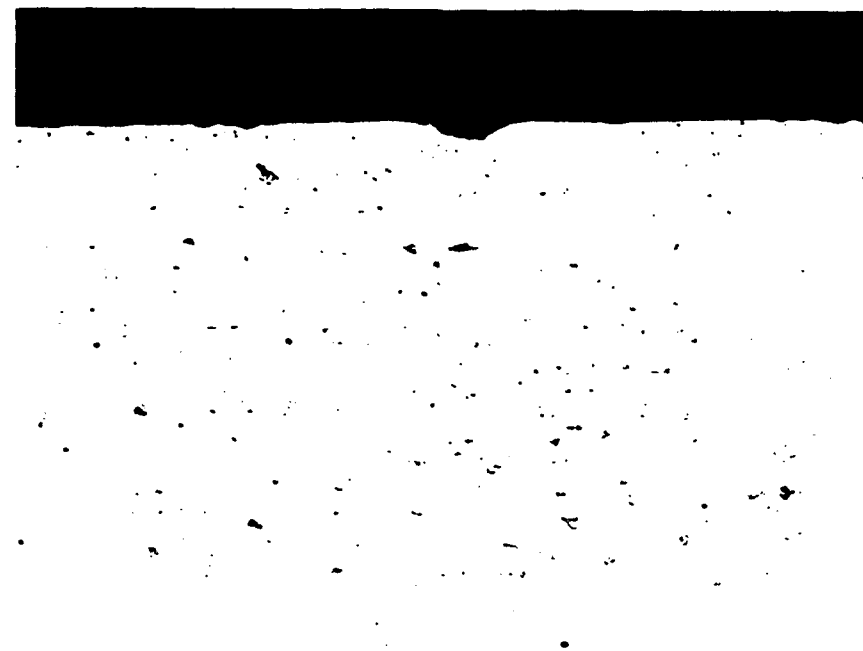
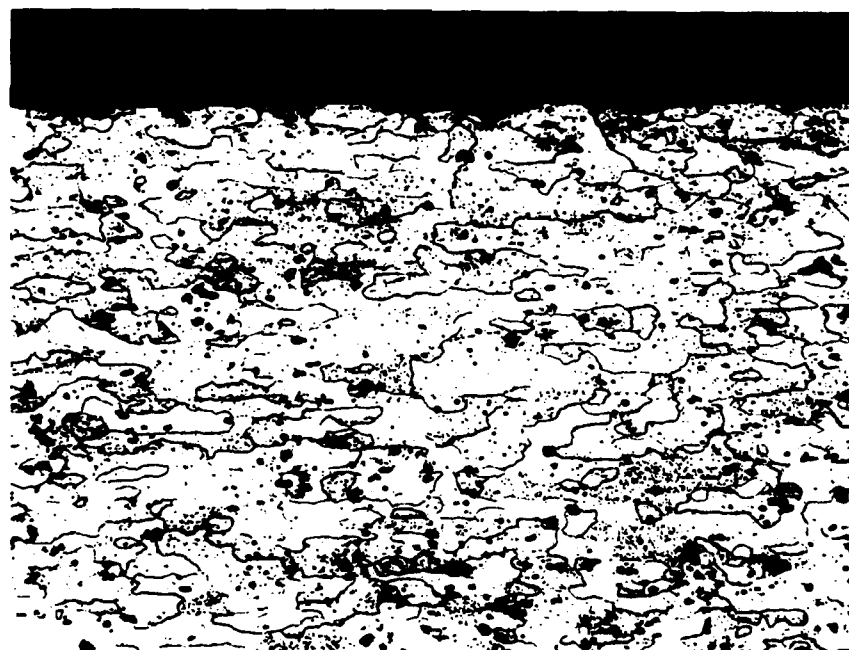
Figure 1. Photomicrographs documenting the microstructure of Specimen No. 1, Alloy 2024-T3 (Chromic Anodized per MIL-A-8625).

etched. Photomicrographs documenting the polished and etched surfaces of the individual samples are provided in Figures 1 through 3.

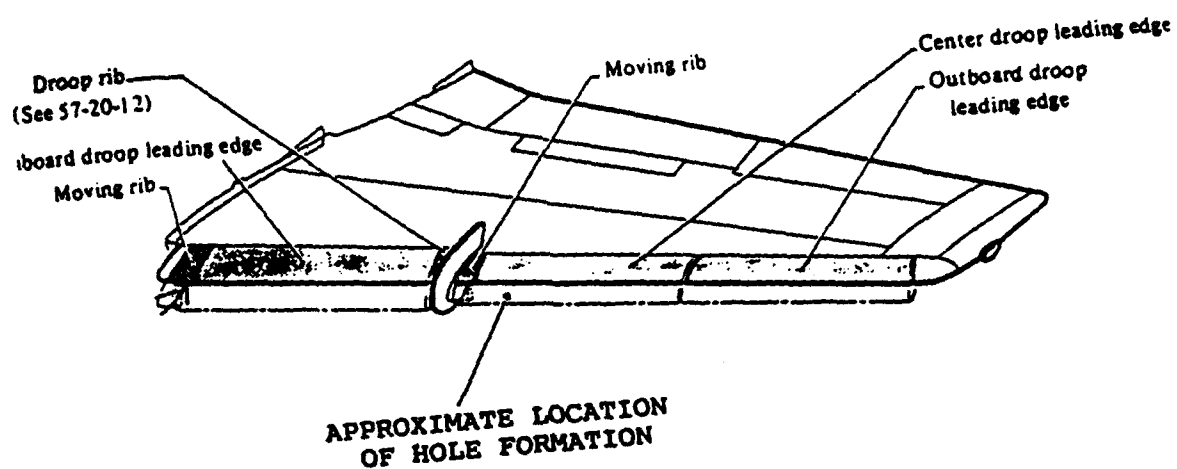
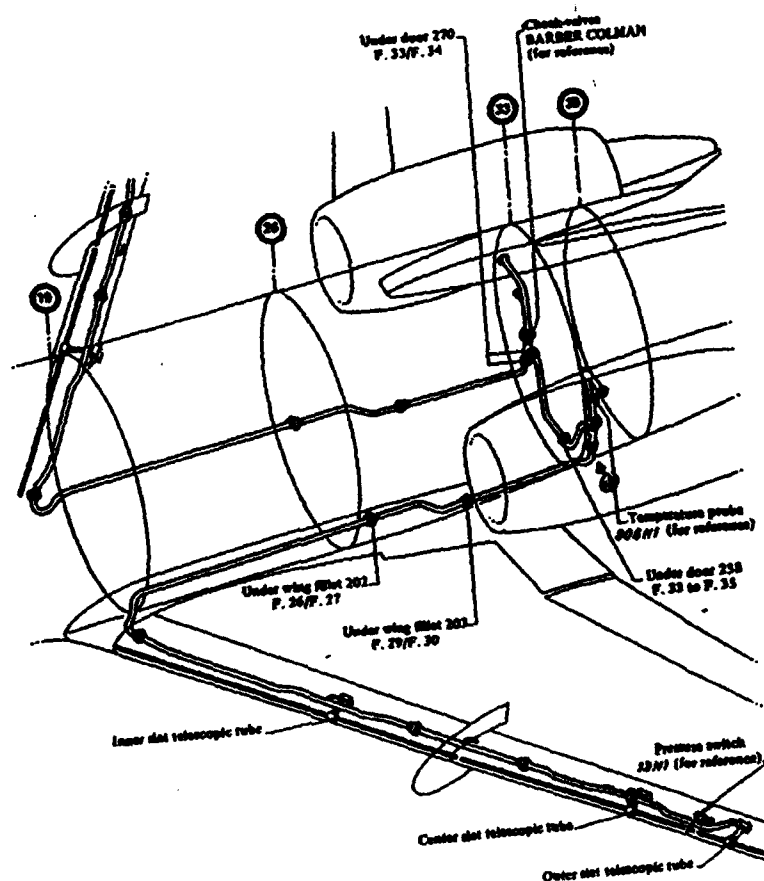
Figure 5. Diagrams of NU-25A RH wing documenting location of corroded slat and anti-icing tubes through inboard and center wing slats.

Corroded Test Sample. The metallographic examination of a small (1.0 inch by 1.0 inch) piece of eroded/corroded wing slat (see Figure 5) that was removed from an HU-25A aircraft (T/N 2131 - MY2014730G01 SN159F) was completed.

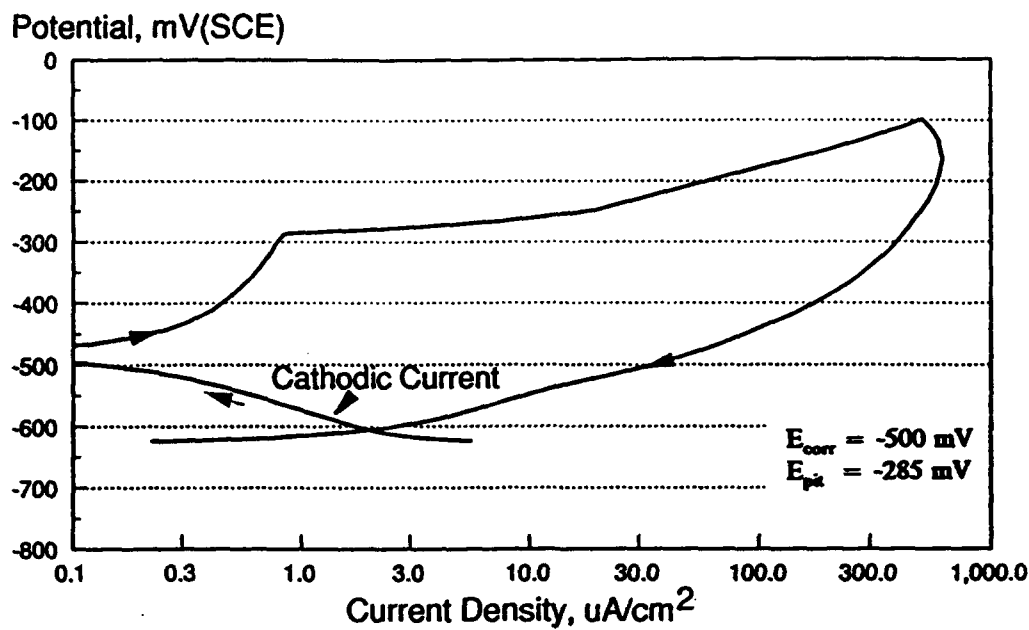
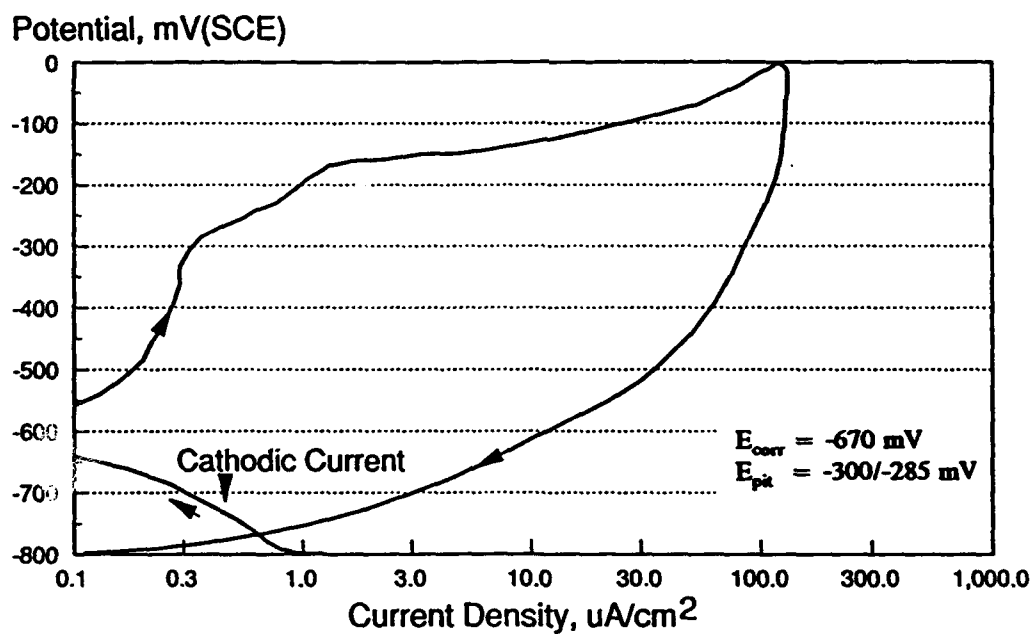
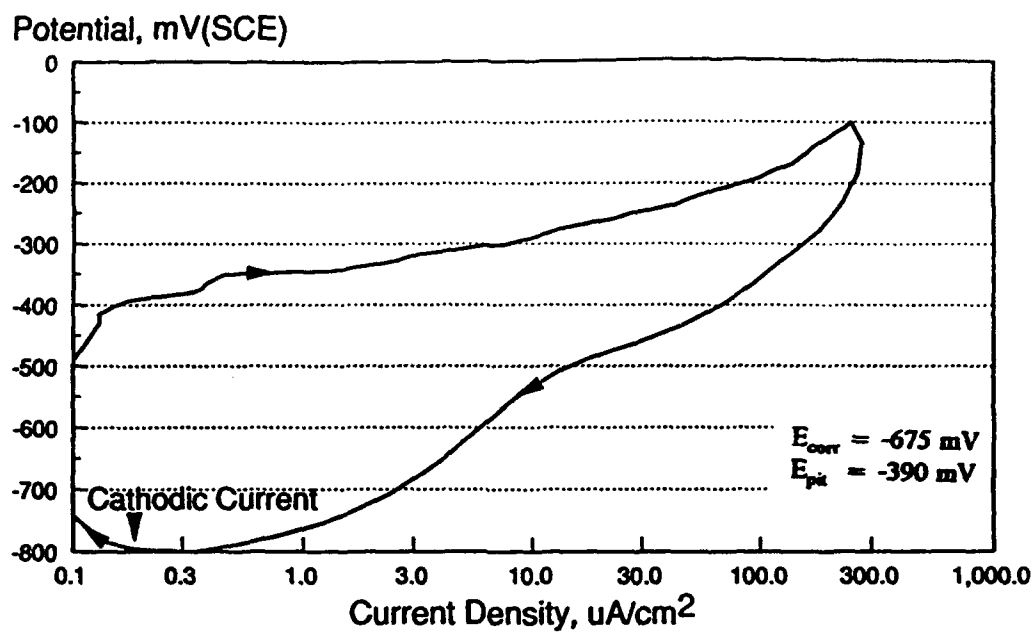
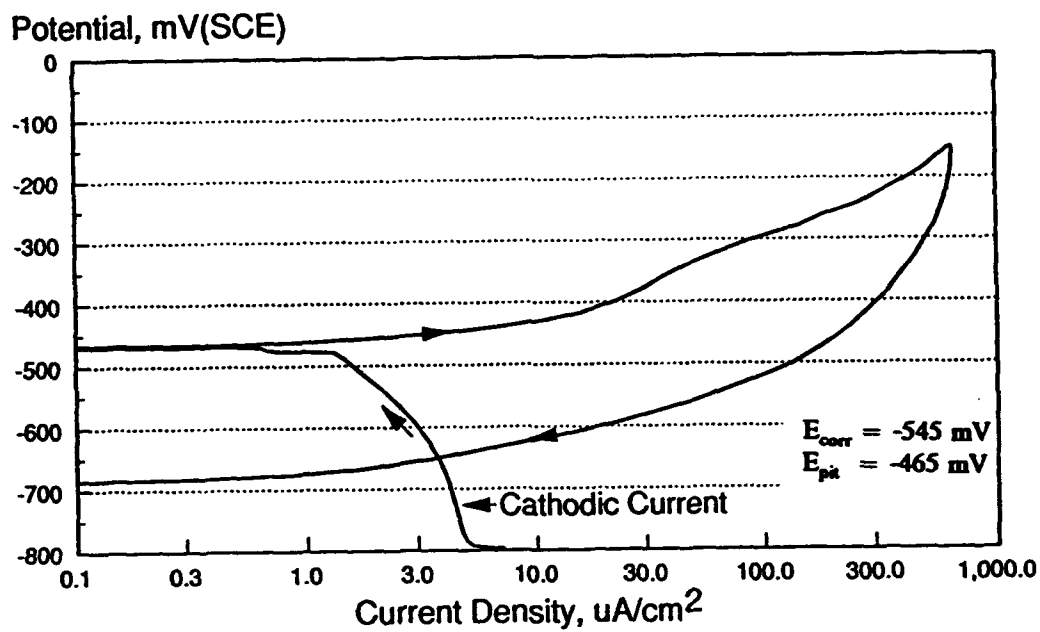
Figure 10. Anodic polarization curves for four aluminum alloys (test environment: 100 ppm each of Cl , SO_4 , and HCO_3 ions).

Figures 10a through 10d document the anodic polarization curves obtained for the four aluminum alloys after testing in ASTM D1384. An analysis of each curve indicates that Alloy 2024-T3 ($E_{np} = -285$ mV) and the French alloy ($E_{np} = -300/-285$ mV) are the most resistant to pitting corrosion. Conversely, the pitting potential measured for the anodized Alloy 2024-T3 sample was approximately -390 mV. The suspected source of this worse-than-expected result may be attributed to the quality of the protective anodized film on the surface of the test sample. Any scratches or discontinuities in the film would result in a decrease in corrosion resistance and an increased susceptibility to pitting corrosion.

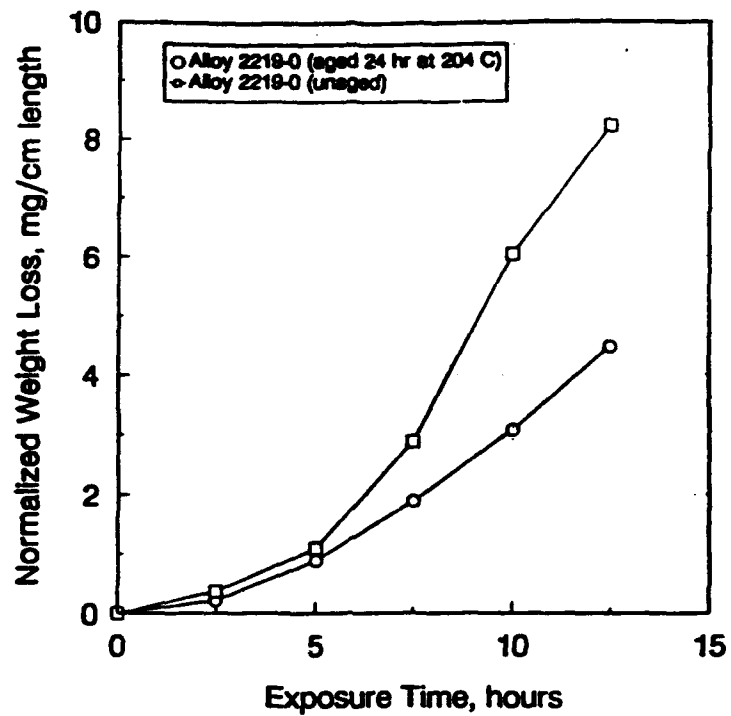
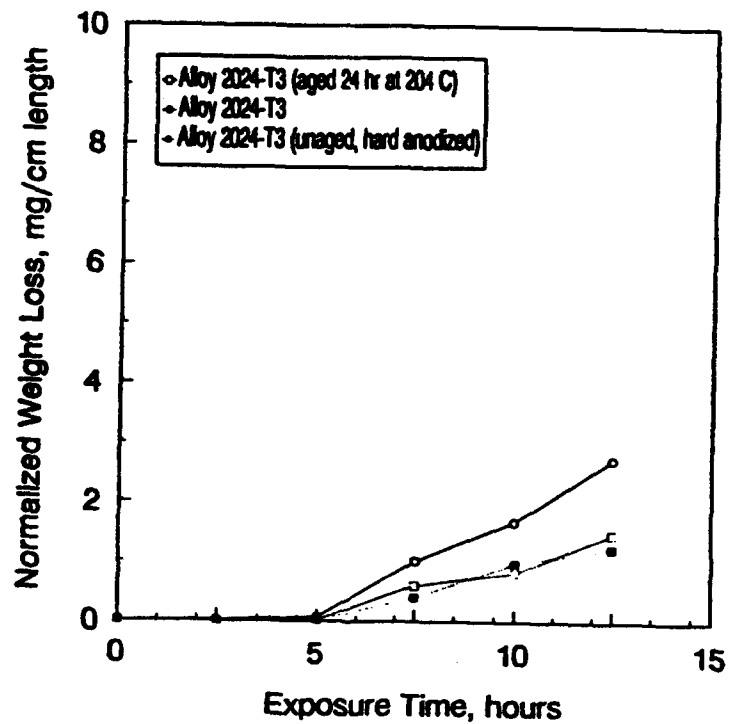
Figure 15. Results of raindrop erosion tests performed on several aluminum aircraft alloys.

Data presented in Figure 15b serve to illustrate the erosion-related performance between the aged (24 hours at 204°C), unaged, and unaged hard anodized (HA) Alloy 2024-T3 samples. The thick (0.0025 to 0.003 inch) anodic film on the test surface of the HA sample was produced to improve corrosion and erosion resistance of Alloy 2024-T3.

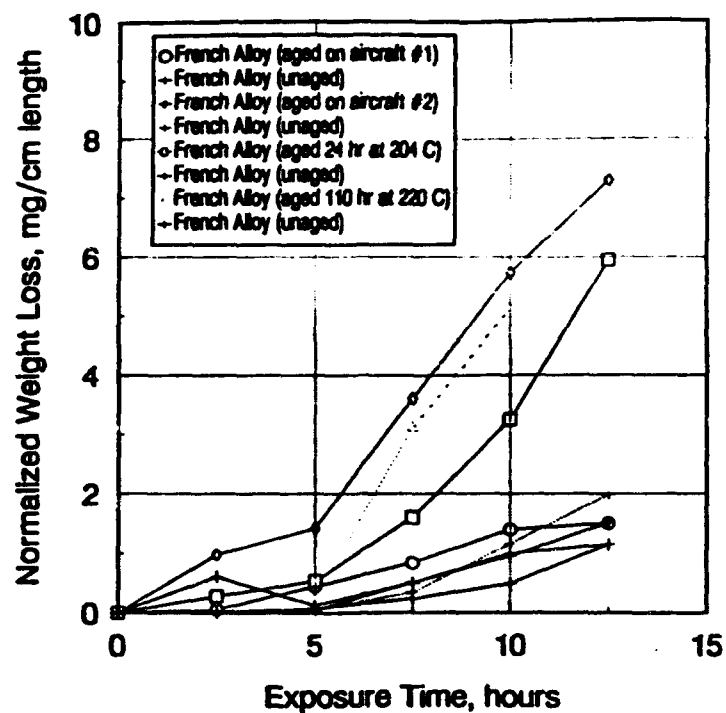
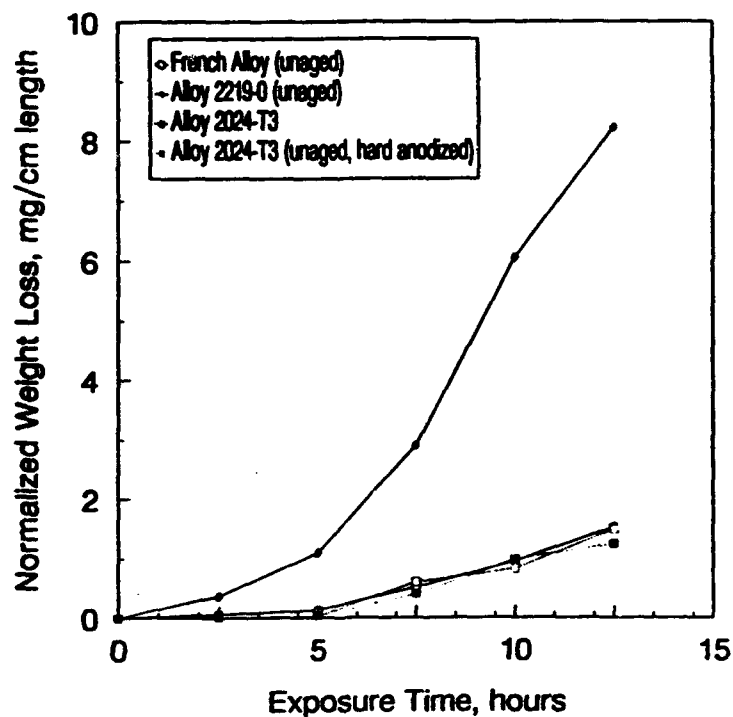
Figure 15. (Continued)

Figure 15c documents the normalized erosion rates measured for the French alloy samples. Data collected for the four unaged (control) samples indicates that the erosion test was reproducible. Normalized rates for this particular sample ranged between 1.01 and 1.99 mg/cm, with the average rate calculated at 1.41 mg/cm.

A comparison among the four unaged samples tested during this task is provided in Figure 15d. The data indicate that the erosion-related performance of the hard anodized and bare Alloy 2024-T3 samples and the French alloy is equivalent. As stated in the previous text, the rate of erosion increased after 5 hours of exposure testing. Conversely, the data collected for Alloy 2219-0 suggest that this aluminum alloy should not be considered as a candidate replacement material for the outer wing slats of the HU-25A aircraft. The same conclusion was obtained from the corrosion testing conducted on this material.
